**Virginia Department of Transportation
ET-Plus 50' (15.24 m) System 4" Channel**

PREPARED FOR:

TR-P35107-06-NC

November 10, 2015

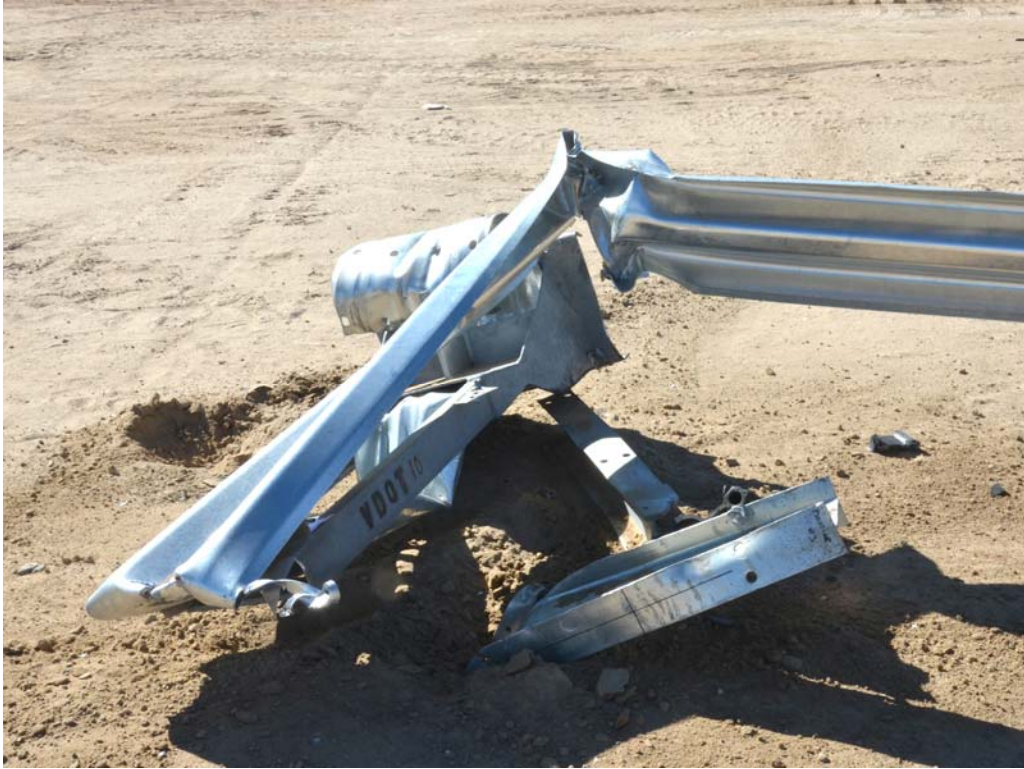
FIGURE 35. Test Article Damage

The test vehicle impacted the ET-Plus 50' (15.24 m) System at a velocity of 102.13 km/h (63.46 mph). The test vehicle impacted the ET-Plus extruder head and pushed it down the guardrail past the HBA post and the first SYTP post. Shortly after the extruder head passed the first SYTP post, the rail kinked and the vehicle proceeded toward the non-traffic side of the guardrail. The vehicle's left front tire impacted the second SYTP post and rolled toward its passenger side. The vehicle landed back on its wheels and rotated counter clockwise back toward the guardrail. The vehicle reengaged with the guardrail and rolled 360° toward its passenger side before landing back on its wheels, on top of the guardrail. The test vehicle came to rest approximately 47.0 m (154.1 ft.) forward and 2.9 m (9.5 ft.) left of its position at the point of impact. An overhead illustration of the test vehicle and test article in their pre-test and post-test conditions is shown in Figure 62 in Appendix D. Sequential photographs of the test sequence are shown on Data Sheet 4.

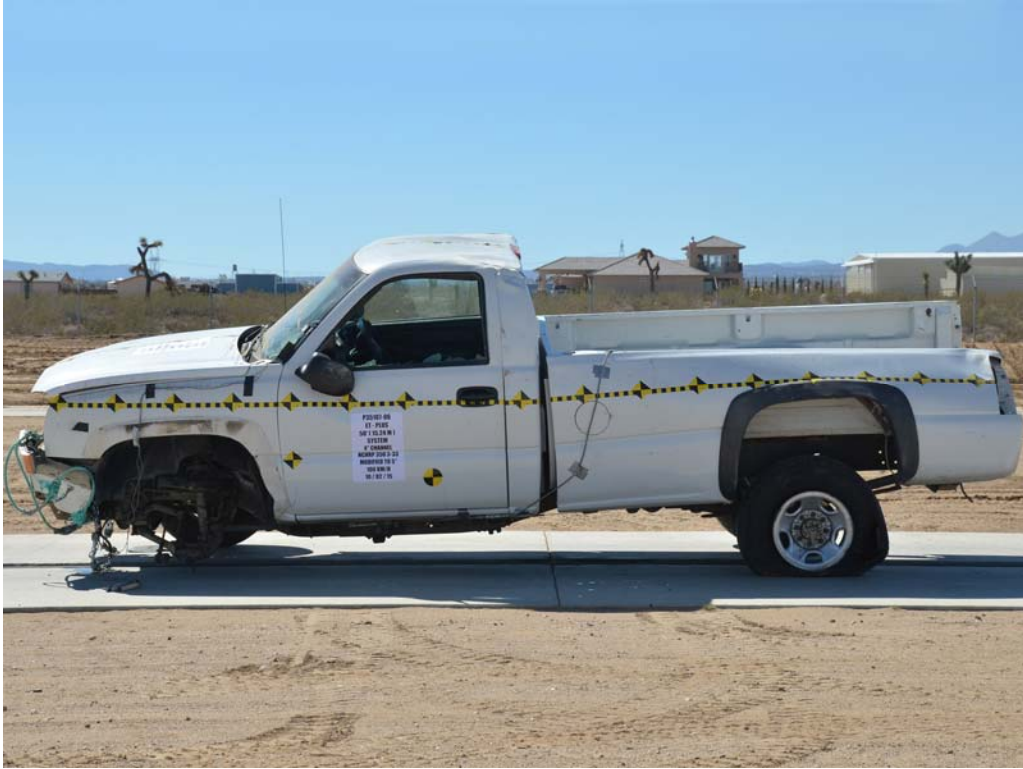
FIGURE 41. Post-Test Left View of Test Vehicle

The vehicle sustained damage to the front end, roof, and across the length of the driver side of the vehicle as a result of the impact with the ET Plus 50' (15.24 m) System. The left front tire was flattened and detached from its axle. The left rear tire was also flattened. The occupant compartment was not penetrated as a result of the impact.
