**Virginia Department of Transportation
ET-Plus 50' (15.24 m) System 4" Channel**

PREPARED FOR:

TR-P35107-06-NC

November 10, 2015

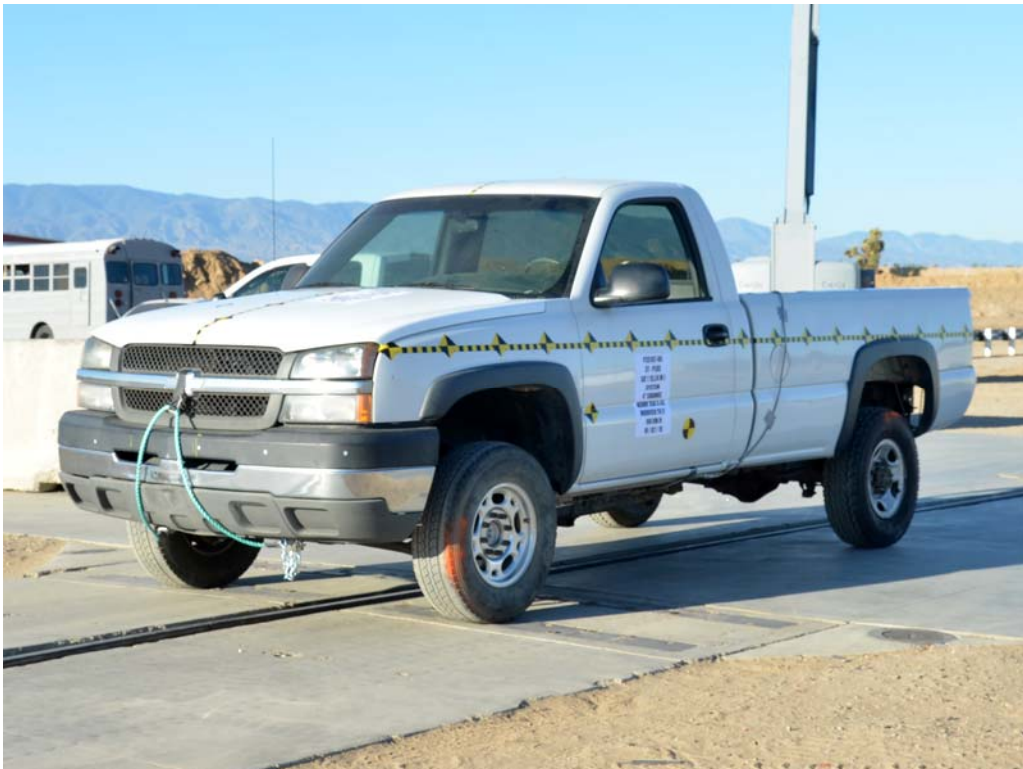
FIGURE 41. Post-Test Left View of Test Vehicle

The vehicle sustained damage to the front end, roof, and across the length of the driver side of the vehicle as a result of the impact with the ET Plus 50' (15.24 m) System. The left front tire was flattened and detached from its axle. The left rear tire was also flattened. The occupant compartment was not penetrated as a result of the impact.

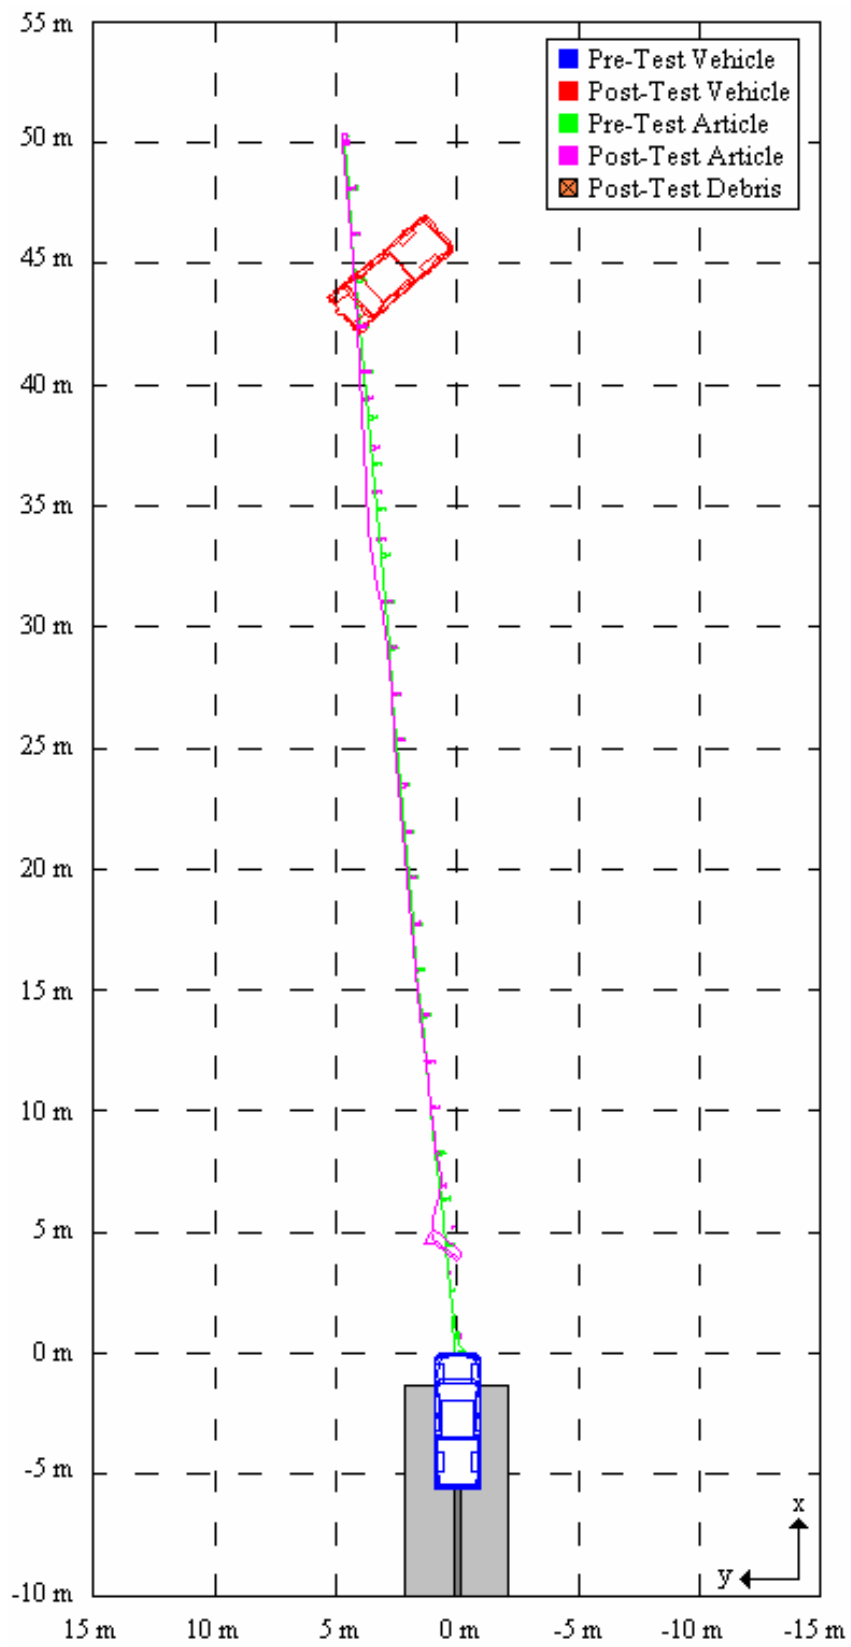
FIGURE 62. Overhead Illustration

The test vehicle impacted the ET-Plus 50' (15.24 m) System at a velocity of 102.13 km/h (63.46 mph). The test vehicle impacted the ET-Plus extruder head and pushed it down the guardrail past the HBA post and the first SYTP post. Shortly after the extruder head passed the first SYTP post, the rail kinked and the vehicle proceeded toward the non-traffic side of the guardrail. The vehicle's left front tire impacted the second SYTP post and rolled toward its passenger side. The vehicle landed back on its wheels and rotated counter clockwise back toward the guardrail. The vehicle reengaged with the guardrail and rolled 360° toward its passenger side before landing back on its wheels, on top of the guardrail. The test vehicle came to rest approximately 47.0 m (154.1 ft.) forward and 2.9 m (9.5 ft.) left of its position at the point of impact. An overhead illustration of the test vehicle and test article in their pre-test and post-test conditions is shown in Figure 62 in Appendix D. Sequential photographs of the test sequence are shown on Data Sheet 4.
